## CONDITION REPORT

| <div>Year</div> <div>2022</div> | <div>Make</div> <div>TOYOTA</div> | | <div>Model</div> <div>COROLLA SE</div> | | <div>Body Type</div> <div>4dr Car</div> | <div>VIN</div> <div>JTDS4MCE1N3509726</div> |

**AutoGrade**  
Grade 1.8 Rough  
[About AutoGrade](#)

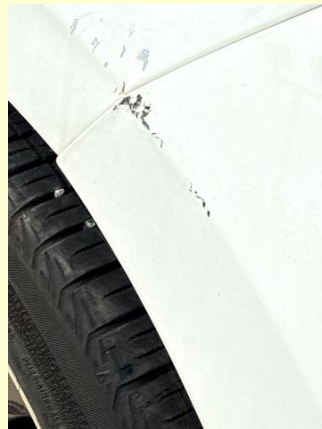
| 07/31/2025 | Front bumper cover scratch heavy | 0.00 | 0.00 | 0.00 | 1.00 | 0.00 | 0.0 |
| | - 1/2 To 1 Inch. | | | | | | |

Front bumper cover  
scratch heavy

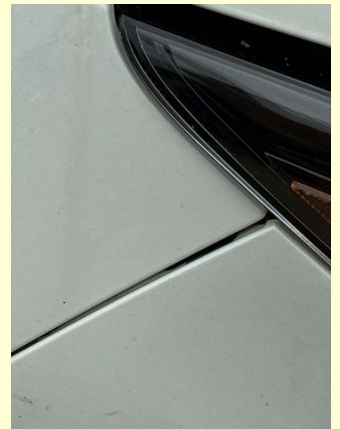
| 07/31/2025 | Front bumper cover misaligned | 0.00 | 1.00 | 0.00 | 0.00 | 0.00 | 0.0 |

Front bumper cover  
misaligned

| | - Repair Required. | | | | | | |

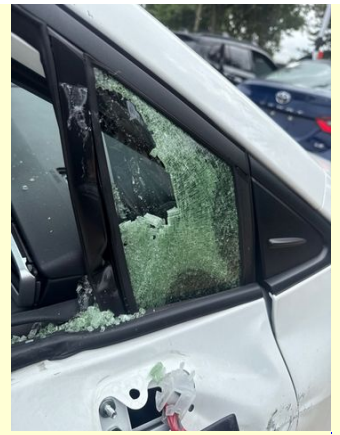
| 07/31/2025 | Rf door glass broken | 60.00 | 0.00 | 0.00 | 0.00 | 0.00 | 0.0 |

Rf door glass broken

| | - Replacement Required. | | | | | | |

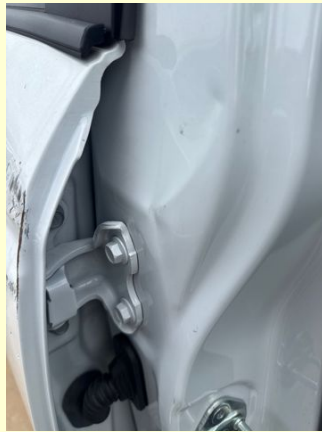
| 07/31/2025 | R b pillar kinked | 0.00 | 0.00 | 0.00 | 0.00 | 0.00 | 0.0 |
| | - 5 to 6in. | | | | | | |

R b pillar kinked

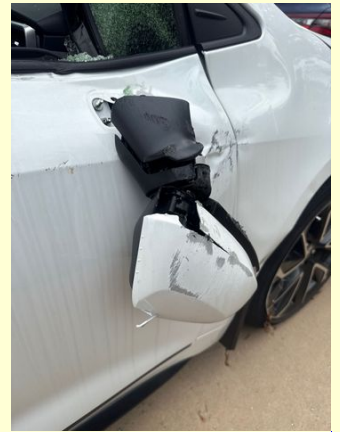
| 07/31/2025 | Rf mirror housing broken | 70.00 | 0.00 | 0.00 | 0.00 | 0.00 | 0.0 |

Rf mirror housing  
broken

| | - Replacement Required. | | | | | | |

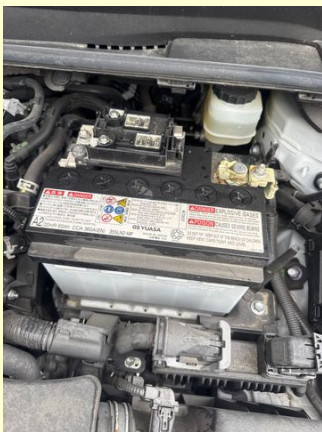
| Inspection Date | Description | Approved | Repaired | Material Estimate | Labor Hours | Labor Estimate | Paint Hours | Paint Estimate | Sublet Estimate |
|---|---|---|---|---|---|---|---|---|---|
| 07/31/2025 | Battery inoperable | | | 150.00 | 0.00 | 0.00 | 0.00 | 0.00 | 0.0 |

Battery inoperable

| | - Repair Required. | | | | | | |
